Project No Flow

A report on non-consuming
meters on occupied SPIDs

Report on Non-Consuming Meters on Occupied SPIDs

Authors	Occutrace – Natalie Martin, David McKenzie Wave – Claire Stanness	Reviewed by	Occutrace – Neil Stewart, Oliver Driscoll, Frances Youngson Wave - Wendy Monk
Version	0.5		
Status	Share with the Market	Date	13th February 2024

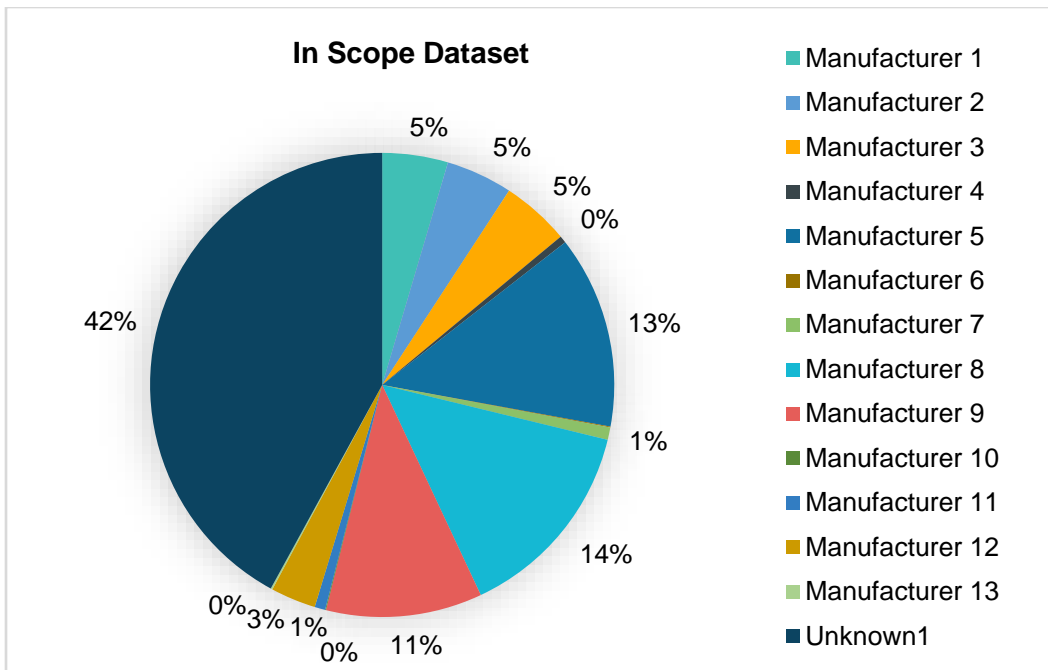
A table displaying the number of manufacturers and their prevalence within the sample is provided below. Notably, the highest number of occurrences is attributed to 'unknown1', indicating instances where the meter manufacturer could not be identified. This finding demonstrates the importance of collecting accurate and complete data to ensure comprehensive analysis.

Meter Manufacturer	Number
Manufacturer 1	74
Manufacturer 2	75
Manufacturer 3	77
Manufacturer 4	8
Manufacturer 5	217
Manufacturer 6	1
Manufacturer 7	14
Manufacturer 8	230
Manufacturer 9	176
Manufacturer 10	1
Manufacturer 11	12
Manufacturer 12	51
Manufacturer 13	2
Unknown1	680
Total	1,618

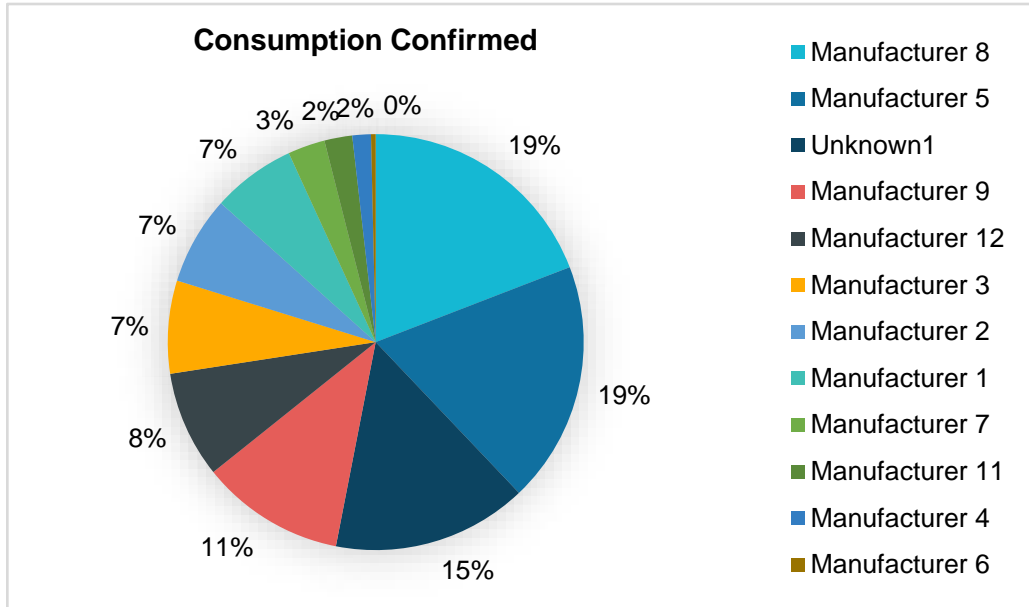
To ensure transparency and provide a comprehensive report, below are charts and tables displaying the outcomes and several perspectives regarding the meters' readings and recorded consumption.

Anon – Meter Manufacturer	Number
Manufacturer 8	53
Manufacturer 5	52
Unknown1	42
Manufacturer 9	31
Manufacturer 12	23
Manufacturer 3	20
Manufacturer 2	19
Manufacturer 1	18
Manufacturer 7	8
Manufacturer 11	6
Manufacturer 4	4
Manufacturer 6	1
Total	277

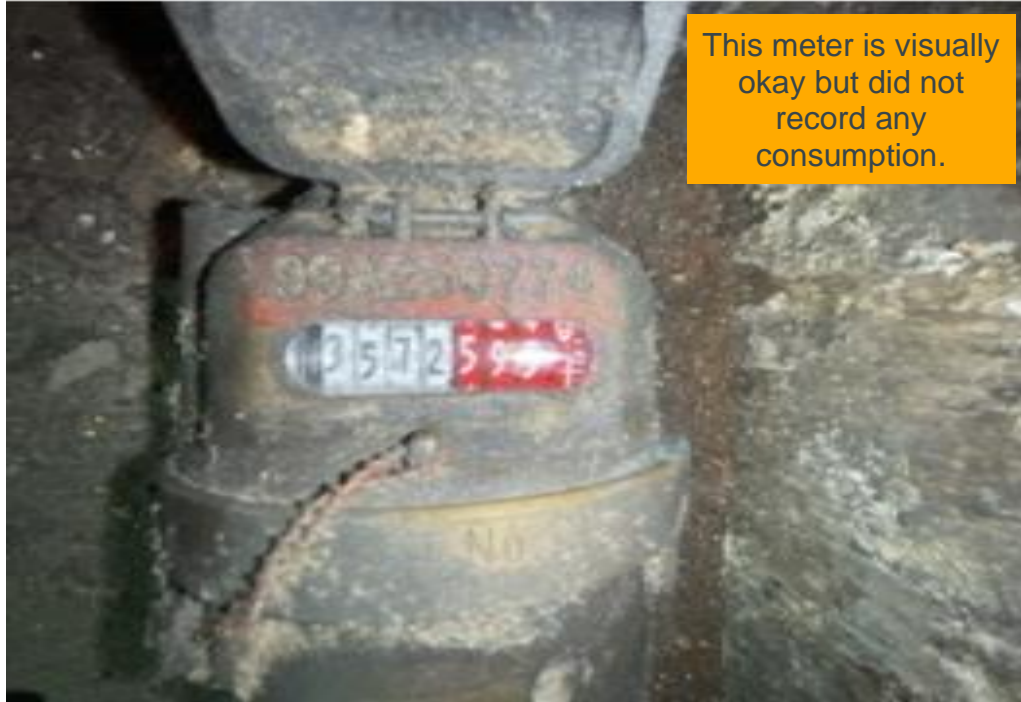
This meter is visually okay but did not record any consumption.

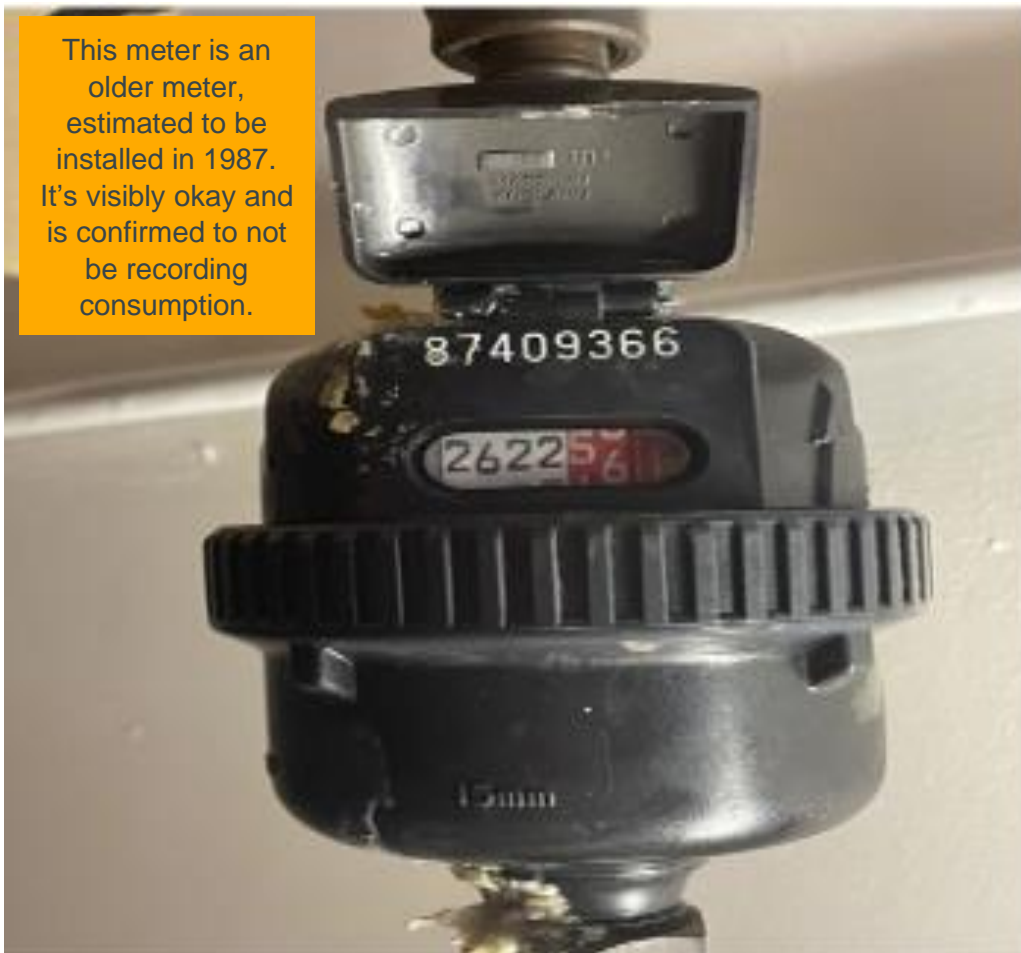
This meter is an older meter, estimated to be installed in 1987. It's visibly okay and is confirmed to not be recording consumption.
